October 11, 2022

Re: Structural Evaluation of 4104 Main Street, Timnath, CO

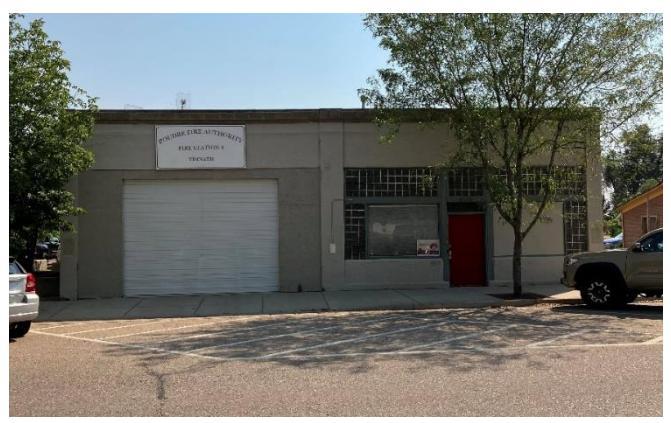
Front (West) View of Building

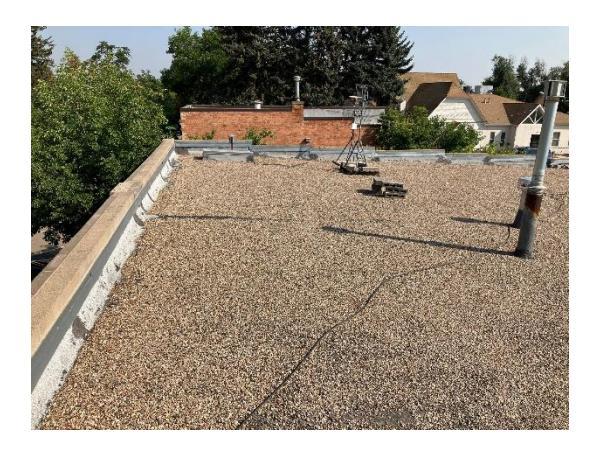
North-West Corner of Roof

The surface of the roof was walked to check for soft areas or other obvious defects. None were found. From the surface of the roof it was determined the structural framing spans in the north-south direction, each way from the center interior bearing wall to the north and south exterior walls.

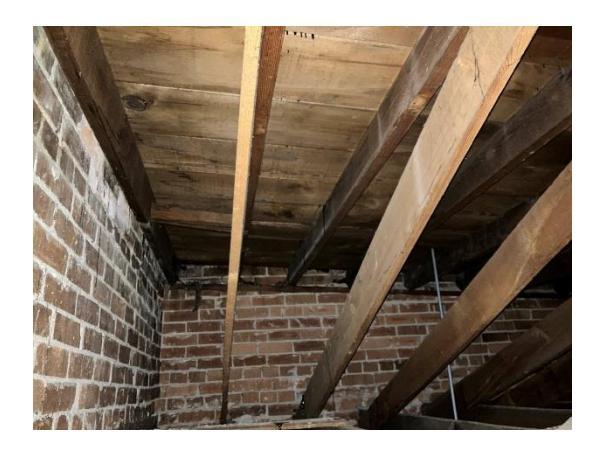
North-West Corner of North Attic

The framing on the north side of the building was partially observed through a hole in the ceiling created during placement of the wall header over the vehicle door on the west side of the building. The 15/8" x 9 ¹/₄" rough sawn ceiling joists, which are spaced at 16" on center, are the primary supporting members for the roof/ceiling structure and are built into pockets in the masonry walls. The 15/8" x 5 ¹/₂" rough sawn roof joists are spaced at 16" on center and are located directly over the ceiling joists. In addition to directly supporting the roof sheathing, they serve to provide additional overall roof support. At the exterior wall the roof joists are supported on a ledge created by a narrowing the masonry wall from thirteen inches to eight and one half inches wide. There are rough sawn 1x4's placed vertically at the center of the span. These 1x4's are nailed to the side of the ceiling joists and rafters (side-nailed). In addition to the vertical 1x4's, there are side-nailed rough sawn 1x6 members extending from each end of the ceiling joists to within several feet of the vertical 1x4's. There are 1x wood roof

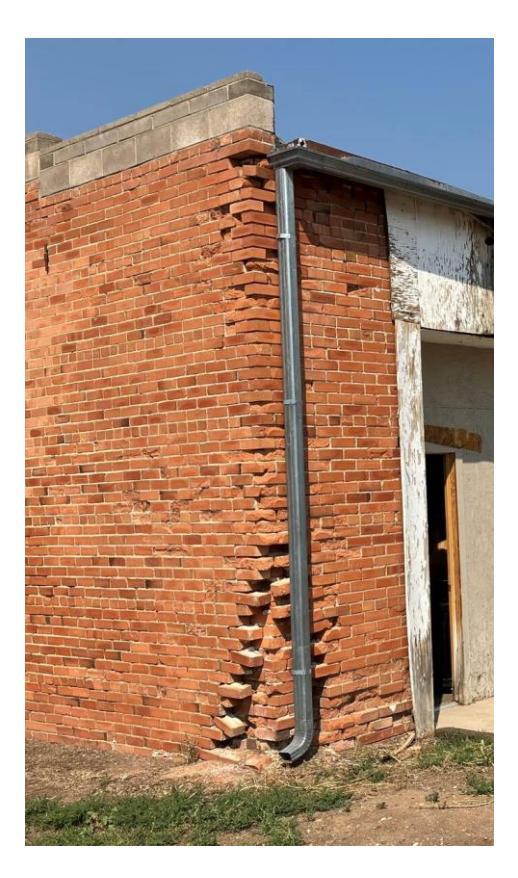
South-East Corner of Building

There are locations where the weathering has resulted in significant degradation of the masonry wall, leading to a potential for eventual partial wall collapse in these areas. The most advanced deterioration is the south-east corner of the building where the mortar has completely, or nearly completely, degraded leaving the bricks at the outer wythe, and some at the inner wythes, loose and unattached. With close observation it can be seen that the masonry wall has bulged outward. This degradation is most likely due to freeze-thaw action caused by saturation of the masonry from water flowing from the roof and running down the exterior face of the wall. A similar situation exists on the northeast corner of the building.

The biggest challenge with the building is the significant degradation of the exterior of the brick masonry walls. As noted above there are significant areas of the exterior walls (approximately 50%) which require some amount of rehabilitation, and areas such as the rear two corners which will need to be removed and replaced.

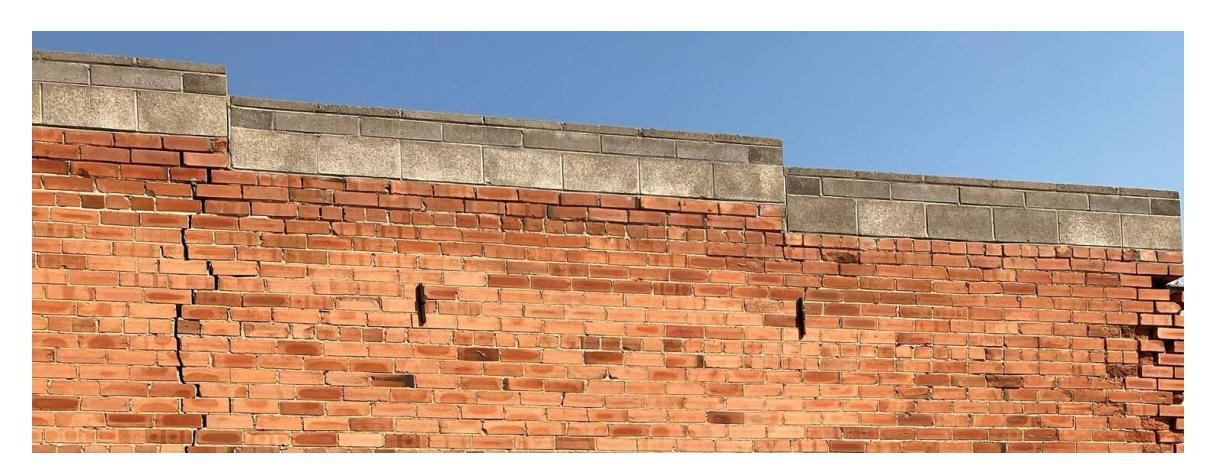
Weathering of the masonry at the top of the exterior walls is significant. It is apparent that the upper portion of the wall was partially removed and replaced with concrete masonry units. It is likely the brick parapets, because of their exposure to the elements, became highly weathered and may have presented a safety hazard prior to their replacement with concrete masonry. The parapets were replaced on the north, west and south sides of the building. There are many areas where significant weathering of the bricks and mortar can be seen below the newer concrete masonry.

Weathering of Top of Brick Masonry on South Wall

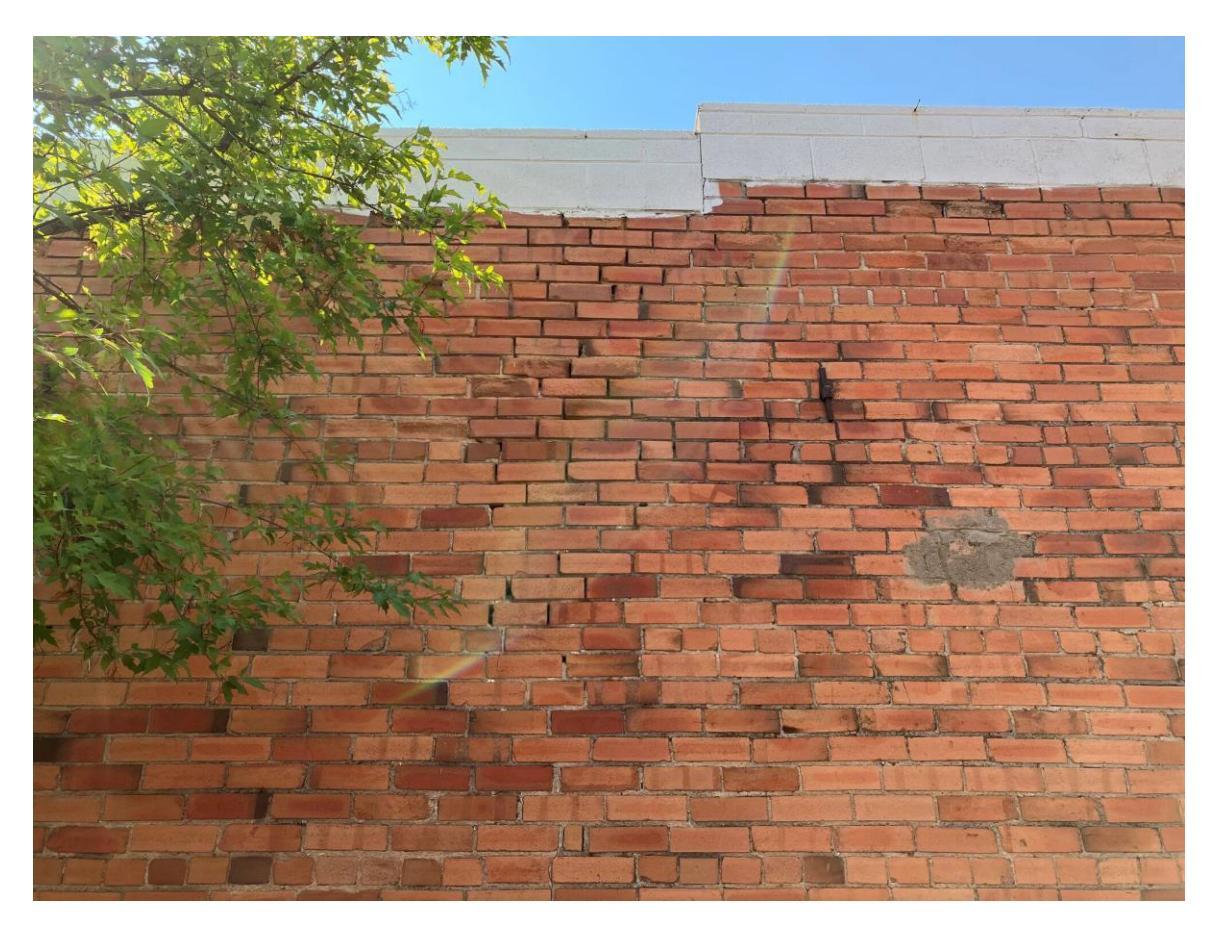
The photo below shows a condition at the north wall. The area of weathering extends down the face of the wall, perhaps due to a previous condition of water saturation due to improper drainage.

Weathering of Brick Masonry on North Wall

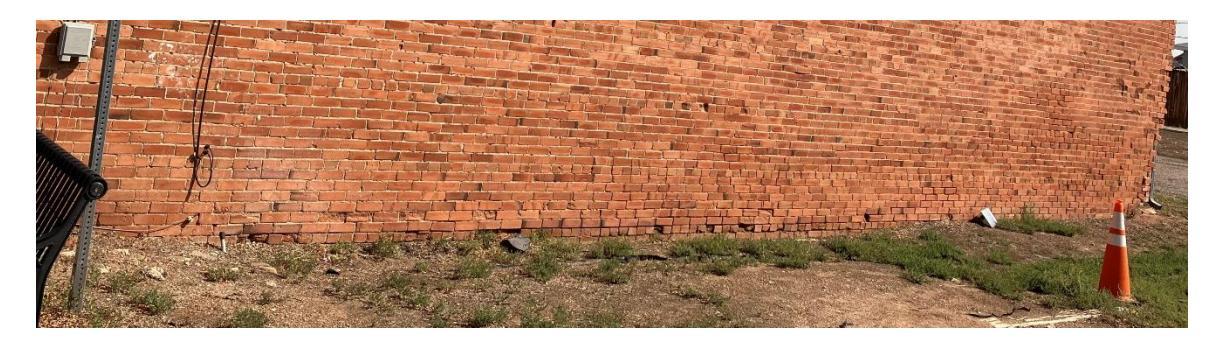
Weathering of the masonry at the bottom of the exterior walls is quite significant. The first photo below shows an overall view of the bottom of wall at the south side of the building. The mortar has degraded to a very friable condition leaving at least the outer wythe of bricks unsupported. Some of the brick units have significantly degraded also. This is likely due absorption of moisture into the masonry wall from the adjacent saturated soils followed by freeze-thaw cycles. It is likely this condition occurs in other areas of the building as well. The next photograph shows a closer view of a portion of the wall and the third photograph shows a six inch long pen inserted into the bed joint showing the mortar is missing in the outer brick wythe.

Overall View of Disintegrated Mortar Joints at Bottom of South Wall

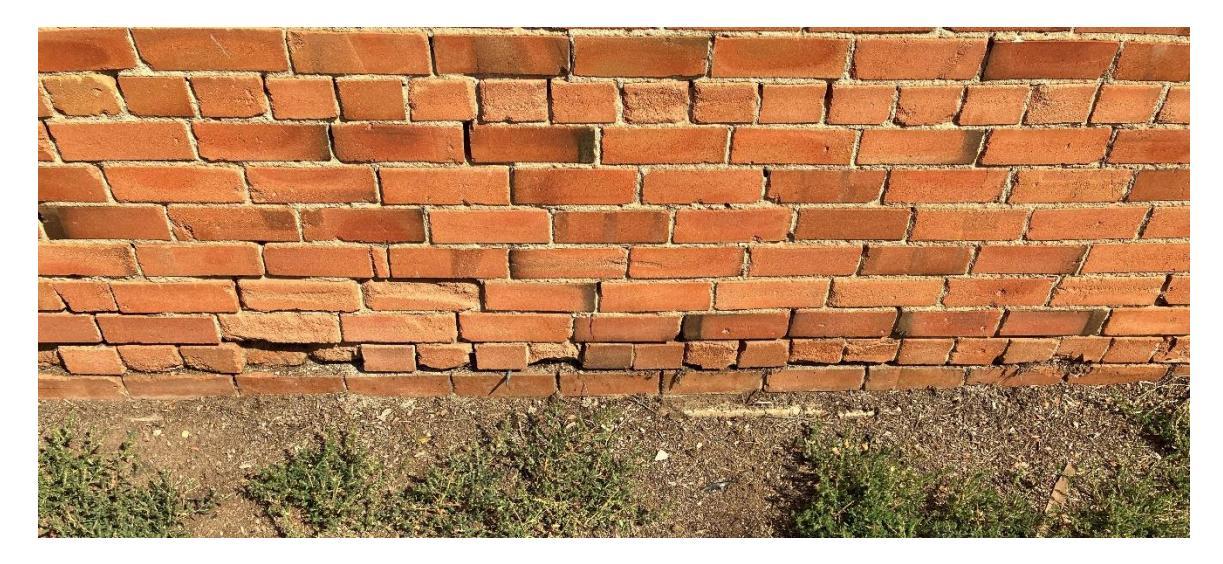
Disintegrated Mortar Joints and Bricks at Bottom of South Wall (pen at center of photograph, several inches above grade)

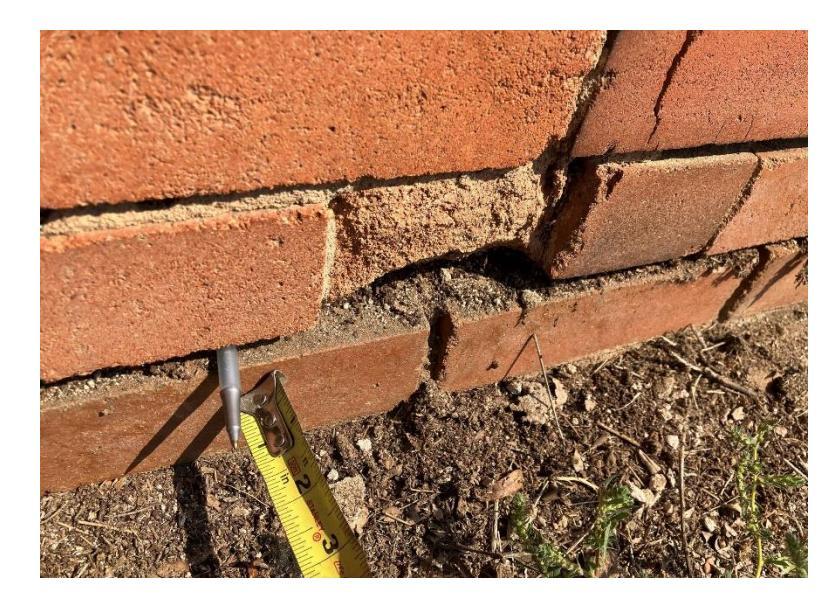
Six Inch Long Pen Inserted into Disintegrated Bed Joint at Bottom of South Wall

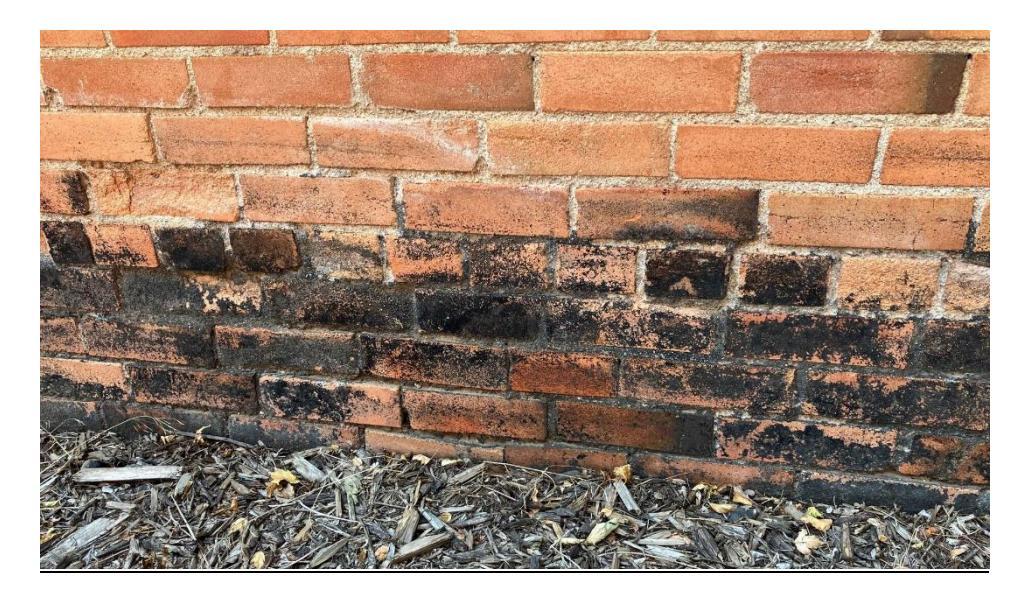
Water Barrier at Bottom of North Exterior Wall (note mortar degradation)

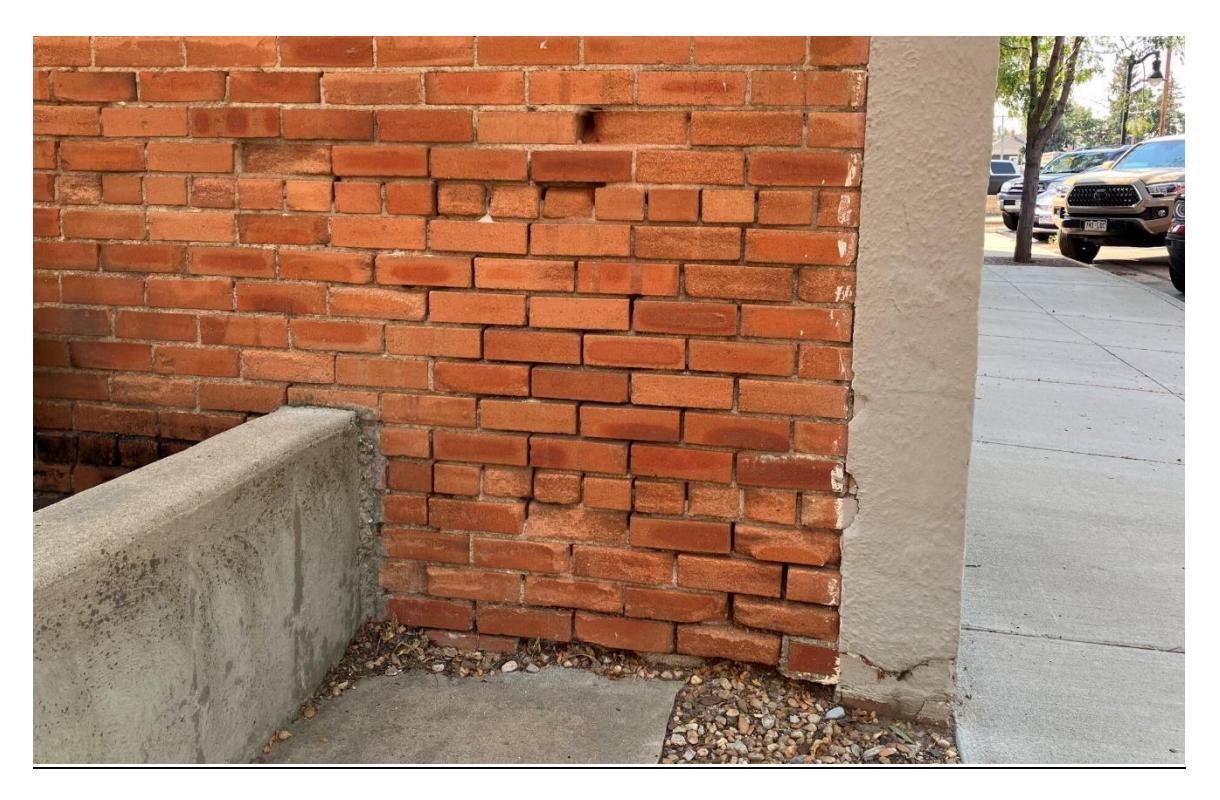
Northwest Corner of Building with Significant Brick and Mortar Degradation

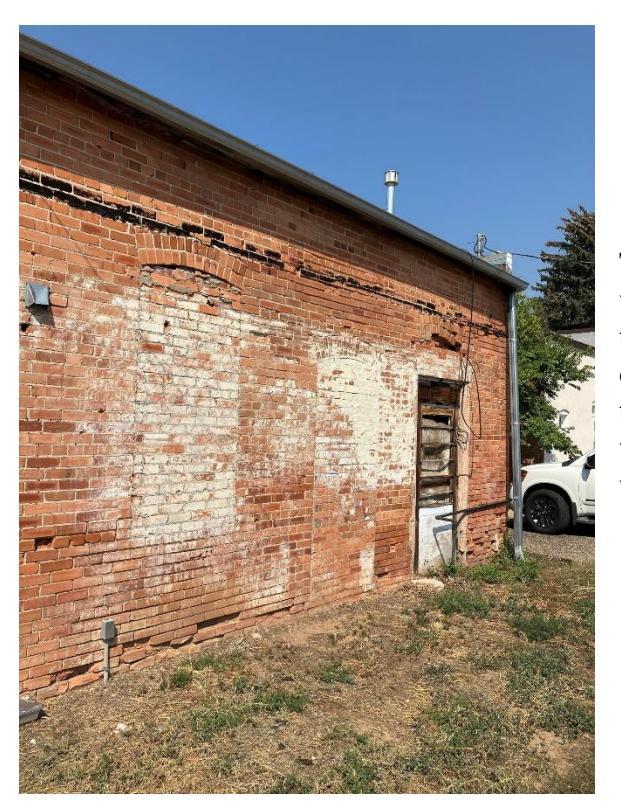
East Exterior Wall

There are other areas on the exterior walls where there is significant degradation of the bricks and mortar. The rear (east) wall of the building exhibits degradation near the bottom of the wall, at each end of the wall as previously noted, above the infilled window openings, and other locations.

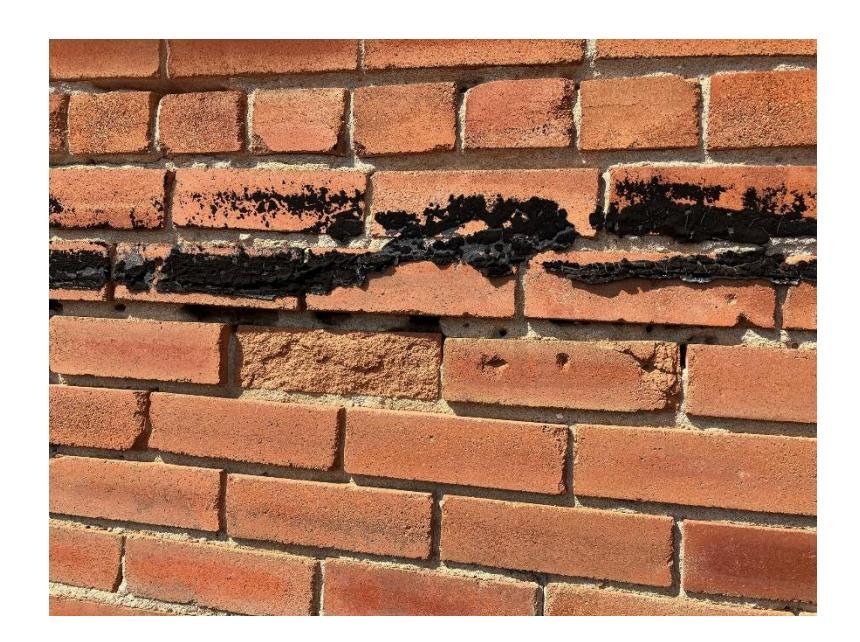
Rear Wall with Degraded Brick and Mortar

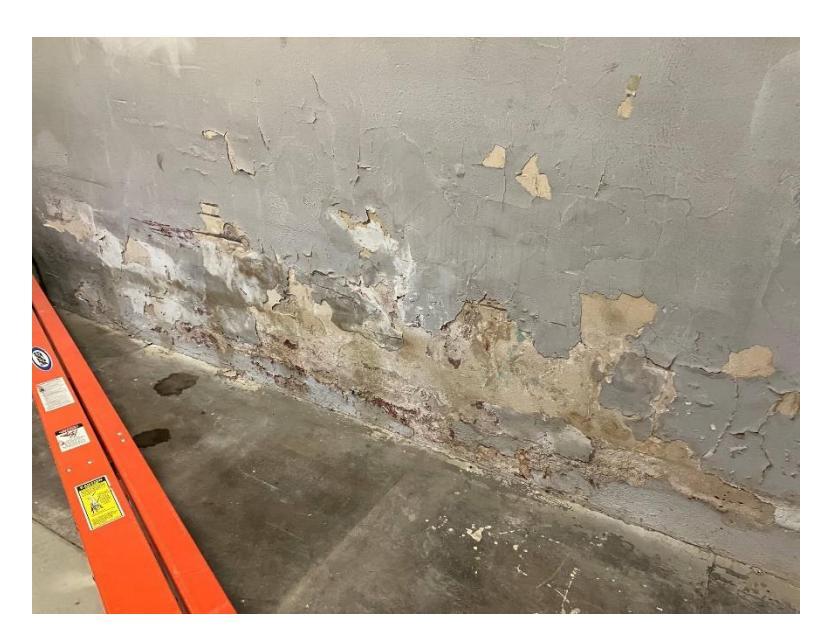
The interior surface of the north exterior wall shows signs of moisture migrating through the wall. The infiltration near the bottom of the wall is likely due to a moist soil condition in the planter adjacent to the wall. Based on the height of the water barrier applied to the exterior surface of the wall, the level of the soil in the planter may have been higher at one time.

Interior Surface of North Wall Near Bottom - Planter on Opposite Side

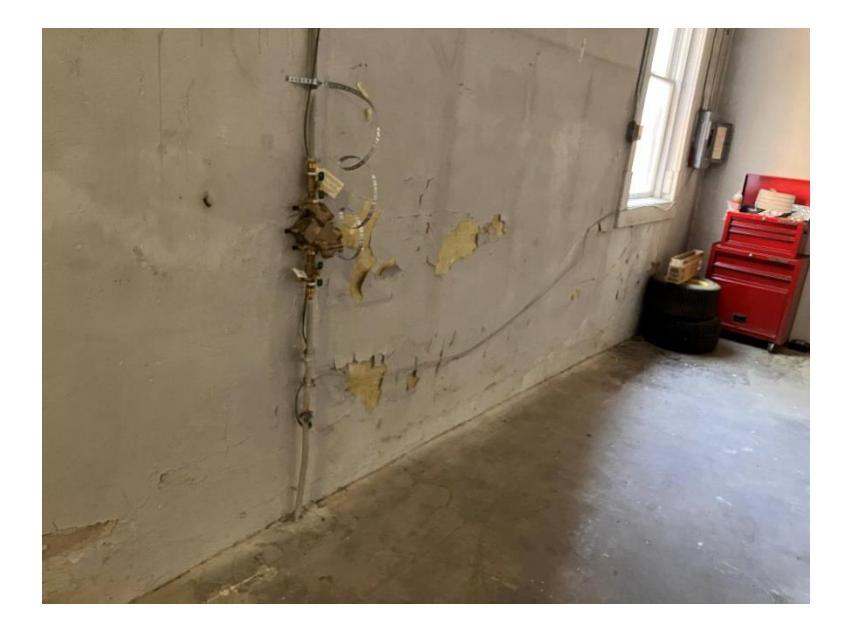
Interior Surface of North Wall Showing Signs of Moisture Migration

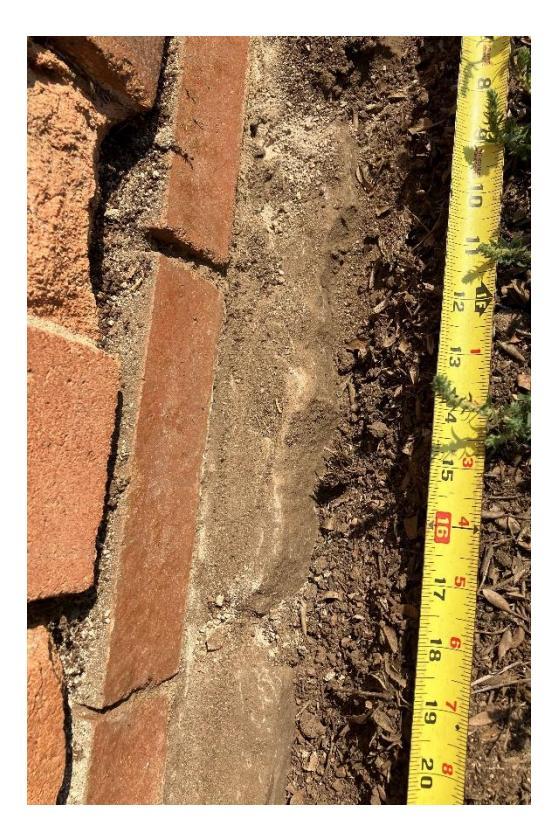
Stone Foundation on South Wall

The exterior masonry walls extend below grade. The foundation is not visible except for one area, near the center of the south wall, a mortared stone wall can be seen.

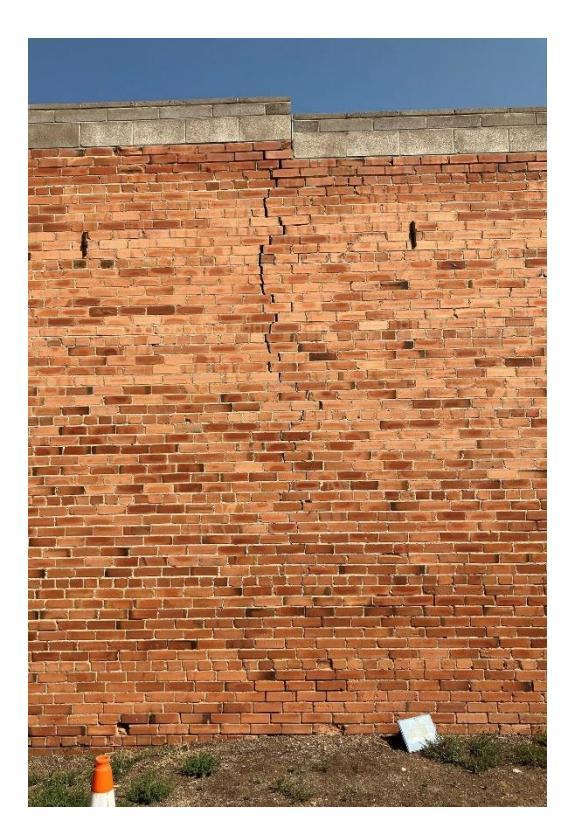
Crack on South Wall

The building exhibits a vertical crack in the south exterior wall and the center masonry wall, approximately eighteen feet west of the east wall. The width of the crack on the south wall varies from near zero at the foundation to approximately ³/₄" in the brick masonry at the top of the wall. It should be noted that the crack in the concrete masonry units at the top of the wall is only one quarter inch wide. This indicates the crack in the brick wall was approximately one-half inch wide when the concrete masonry units were installed, and has increased one-quarter inch since then. It is my opinion that except for the movement which caused the above noted wall cracks, the foundation appears to be performing adequately.
